Before we arrive for your Service Work -

SAFE-GRAIN INC.			
LOVELAND, OHIO 45140			
TITLE: REQUIRED GRAIN DEPTH IN BINS FOR INTERNAL BIN TEMPERATURE CABLE & LEADWIRE SERVICE			
SIZE:	DATE: 09.25.17	DWG NO. A-89-71-T1	DRAWN BY:

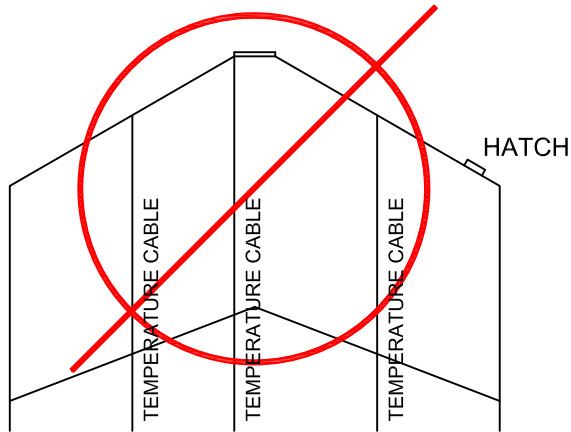
GRAIN IS TOO LOW FOR SAFE ENTRY AND SERVICE
